Car rear and side collisions with pedestrians and cyclists

Compact accident research

Unfallforschung
der Versicherer

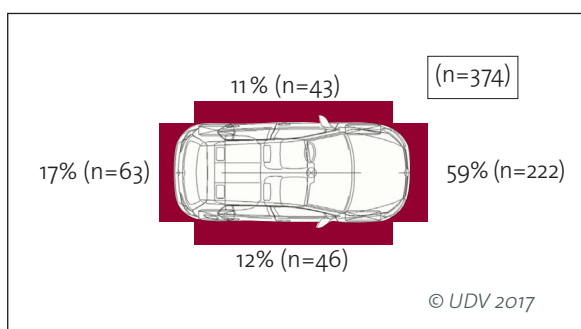
Figure 1 shows the frequencies of different initial contact point locations (impact location) on cars in collisions with pedestrians. It reveals that collisions with the side of a vehicle (side impacts) are the second most frequent type at 23 percent. Collisions with the left and right side of the vehicle occur with similar frequency, but a significant proportion of collisions (17 percent) occur at the rear end of the vehicle (rear impacts).

Figure 1: Distribution of impact locations on the car (initial impact at the car) in collisions between cars and pedestrians

As figure 1 shows, collisions between a pedestrian and the left- or right-hand side of a vehicle accounted for 23 percent of the accidents. There is no significant difference in the number of cases involving the left and right sides of vehicles. Children aged 12 or younger were involved in twice as many collisions with the right-hand side (in 11 cases, accounting for 24 percent of all accidents) as with the left-hand side (5 cases, amounting to 12 percent of the total). In 25 of the 89 cases (28 percent), the pedestrian had contact with one of the vehicle's wing mirrors. In over half of these cases (15 out of 25), the pedestrian was hit only by the wing mirror (17 percent of all side-impact collisions). Figure 5 shows examples of collisions between pedestrian and the car's wing mirror.

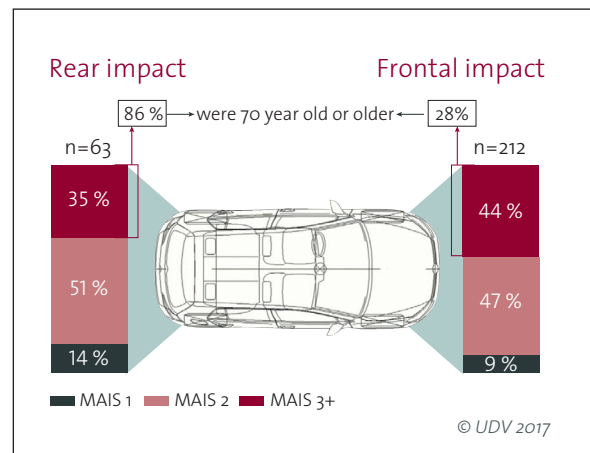
If you compare only the seriously injured pedestrians (MAIS 3+) in frontal and rear impacts with each other (figure 3), the percentage for rear impacts (35 percent) is not much lower than that for frontal impacts (44 percent). However, it is noteworthy that 86 percent of the seriously injured pedestrians in rear impacts were at least 70 years of age, compared with 28 percent for frontal collisions. Although the collision speeds in rear impacts were significantly lower than in frontal impacts, the advanced age and thus greater vulnerability of the injured pedestrians may offer a plausible explanation for this. Further detailed analyses show that two-thirds of the relevant injuries suffered were caused by a secondary impact with the ground. In frontal impacts only 10 percent of injuries were caused in this way.

Figure 3: Comparison of the severity of pedestrian injuries in rear and frontal impacts

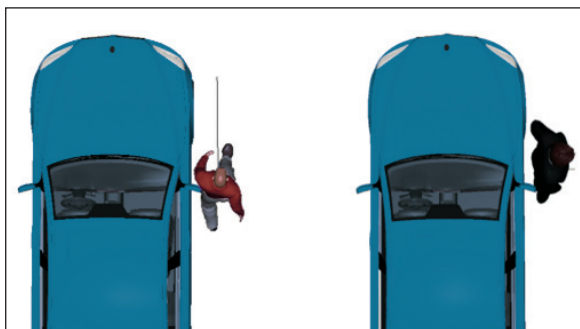
Figure 5: Examples of collisions between a pedestrian and a car's wing mirror (on the left, the pedestrian is walking in the same direction as the car is moving; on the right, the pedestrian is standing with his back to the vehicle as it moves past)

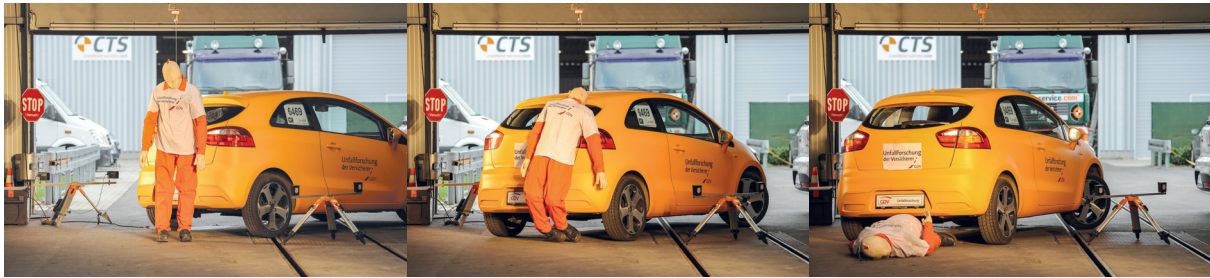
Figure 6: Collision with a reversing car during a parking manoeuvre

A crash test was performed in order to recreate the scenario of a parking manoeuvre with a reversing car that collides with a pedestrian. During the test the car was driven backwards against a standing dummy at a speed of 8 km/h and then it was slowed down to standstill. The image sequences in figure 6 show the kinematics of the dummy during the impact against the rear end of the car. The crash test demonstrates that even at low speeds of the car, the pedestrian is being hurled to the ground by the vehicle.

The dummy kinematics during the impact with the car and the subsequent fall to the ground indicate that the same injury pattern would have occurred as found in analyses of real-world accidents.

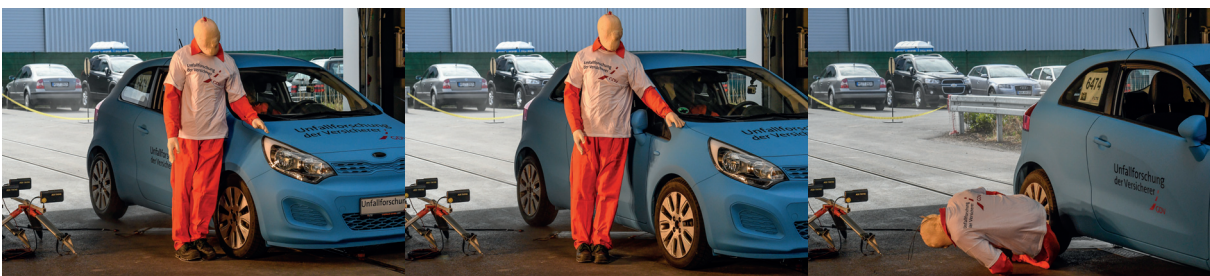
Accident analyses have shown that, for certain accident circumstances, the wing mirror of the car may have an influence on pedestrian kinematics and injury occurrence. For one of these scenarios a crash test was performed showing how the car hits the pedestrian with the right wing mirror. The car was travelling at a speed of 40 km/h and the pedestrian was standing, facing the car's direction of travel. The image sequences in figure 7 show the situation right before, during and after the side-swipe impact between dummy and wing mirror. The contact with the wing mirror resulted in the pedestrian falling to the ground and in injuries being mainly caused by the ground. This outcome correlates with the findings from real-world accident analyses.

A new type of dummy that has been originally developed for the work of accident experts was used for both crash tests.

Figure 7: Collision with the wing mirror of the car that passes by

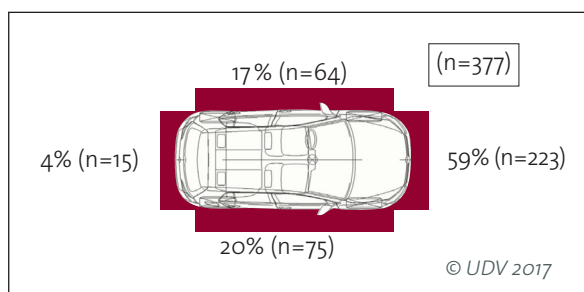
Figure 8 shows the frequencies with which different impact locations on cars are involved in collisions with cyclists. 37 percent (n=139) of all accidents between cars and cyclists were side-impact collisions (side impacts), whereas rear-end collisions (rear impacts) accounted for only 4 percent (n=15). It is noteworthy that in 18 percent of the side impacts (n=25), the cyclist collided with a door that was being opened. These accounted for around 7 percent of all collisions between cyclists and cars in which the impact location on the car is known (n=377). 24 of these cases occurred on the left-hand side of the car. In 23 of these 24 cases it was the driver's door that was hit. However, as with pedestrians, collisions with the front of the vehicle clearly dominated.

Figure 8: Distribution of impact locations on the car (initial impact at the car) in collisions between cars and cyclists

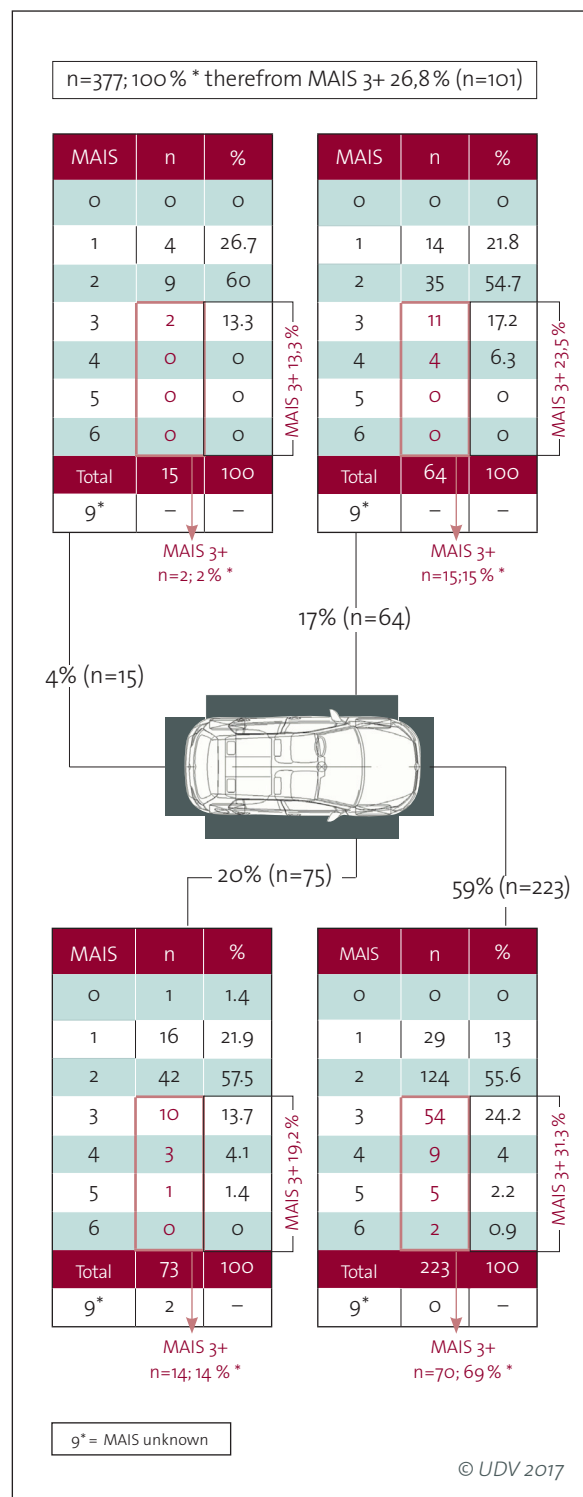
When we look at injury severity by impact location on the car, we see that, as with pedestrians, the front of the vehicle dominates (figure 9). In frontal impacts 31 percent of the injured cyclists sustained MAIS 3+ injuries. These accounted for 69 percent of all cyclists with MAIS 3+ injuries in the accident material. Collisions with the sides of vehicles came next. In collisions with the left-hand side of the car, 24 percent of cyclists sustained serious injuries (MAIS 3+), and in collisions with the right-hand side, it was 19 percent. In rear impacts, 13 percent of the cyclists were seriously injured.

Figure 9: Severity of cyclists' injuries by impact location on the vehicle

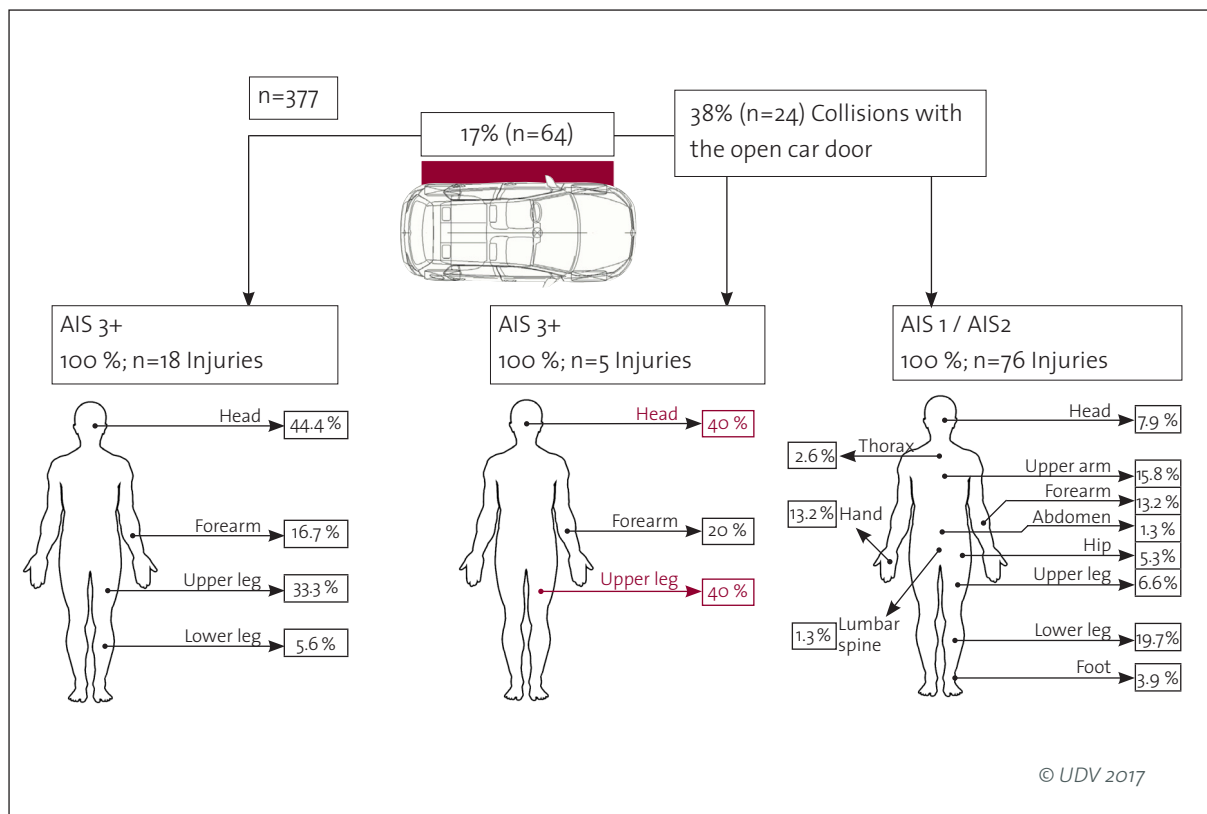
Collisions of a cyclist with a car door that was being opened were found to have happened almost exclusively on the left-hand side of the vehicle, indicating a need for further analysis of this accident constellation. Figure 11 shows the injuries of the cyclists in these situations by region of the body.

Figure 11: Severity of the injuries sustained by the cyclists to different regions of the body in collisions with the driver's door

clist and the final position of the bicycle. The points of impact of the cyclist with the car door essentially explain the injuries to the head and extremities derived from the accident data and shown in figure 11.

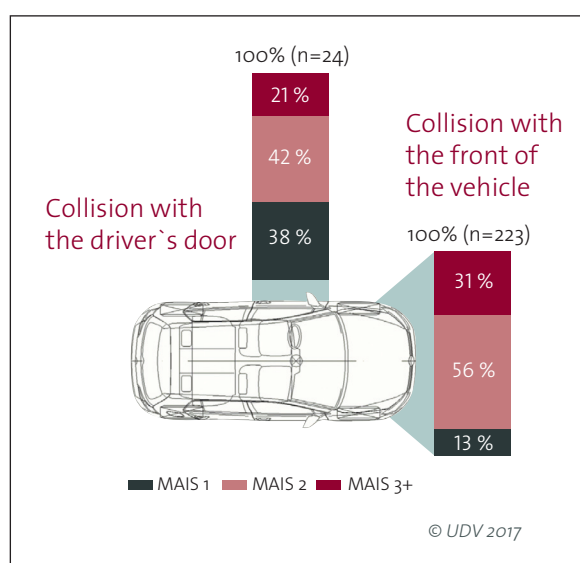
If we compare the severity of the injuries sustained by the cyclists in collisions with the front of a vehicle with that of cyclists who collided with a door, we find a different distribution within the two groups (figure 12). On the one hand it is noticeable that 21 percent of all injuries sustained in collisions with a car door are MAIS 3+ injuries. However, in comparison to that, frontal impacts are more severe as they result in 50 percent more MAIS 3+ injuries.

Figure 12: Severity of the injuries sustained by cyclists in collisions with the driver's door compared with collisions with the front of a vehicle

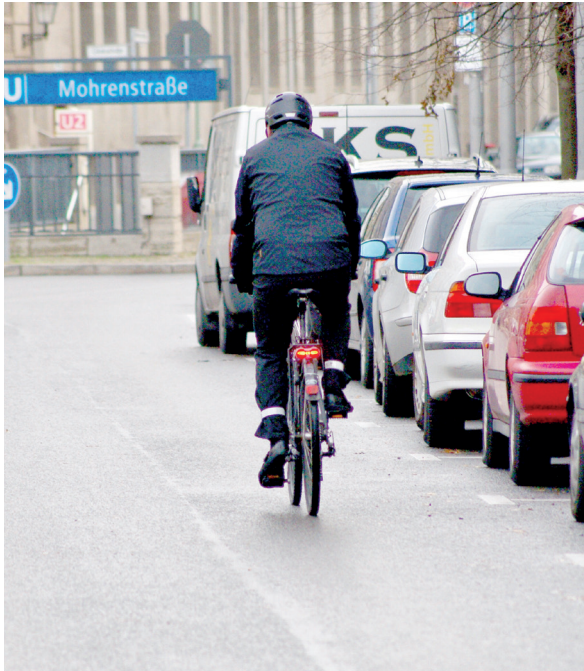
Figure 13: Example of an infrastructure with no separate path for cyclists that is typical for this accident constellation

When we look more closely at these 24 cases in which the cyclist collided with the driver's door, it is noteworthy that in 19 cases (79 percent of the total) the cyclist was riding on the road and attempting to pass the parked vehicle. In most cases in the material studied, there were no separate cycling facilities at the accident location (see examples in figure 13).

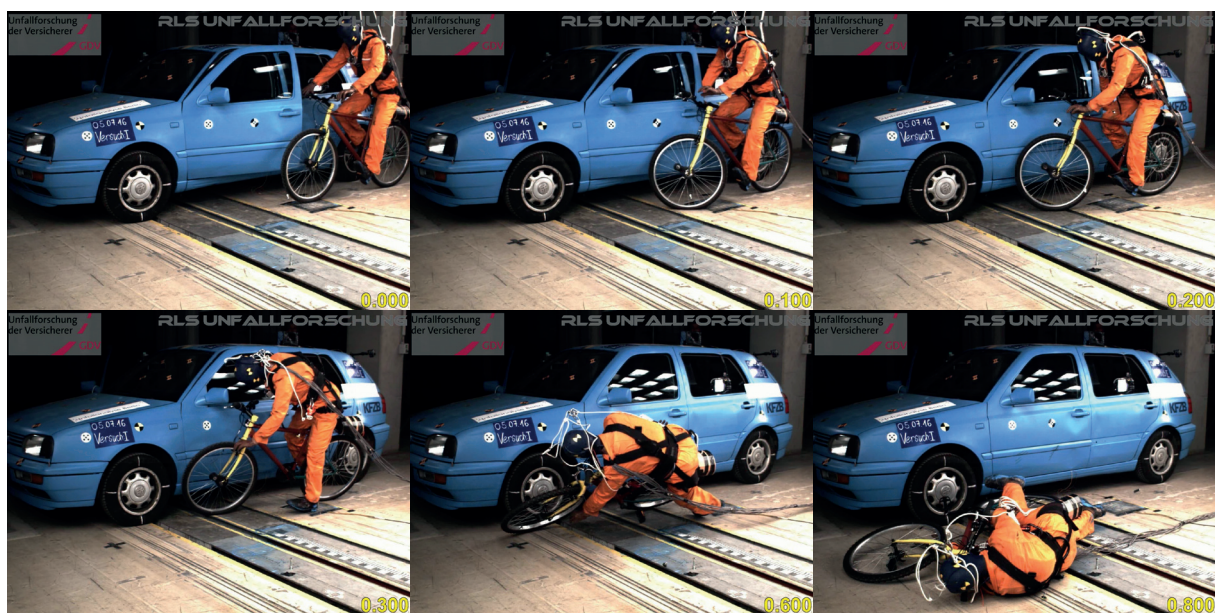
In order to reconstruct the kinematics involved in these collisions, crash tests were carried out in a project of the Department of Motor Vehicles at TU Berlin. A dummy sitting on a bicycle was pulled towards an open car door at a speed of around 14 km/h. The bicycle traveled along a rail until shortly before the collision. The dummy was also released from its guide rail shortly before the collision. The bicycle and dummy were thus able to move freely. The angle at

Figure 14: Collision with a driver's door open at an angle of 26.5 degrees and with a small overlap in the handle area of the handlebar

which the car door was opened was varied. The dummy was fitted with measuring equipment. The sequences of images shown in figures 14 to 16 clearly show the effect of the angle at which the car door is open on the kinematics of the cy-

The larger the angle at which the door was open, the shorter the distance the cyclist was thrown, and in this case the final positions of both the cyclist and the bicycle were near the door.

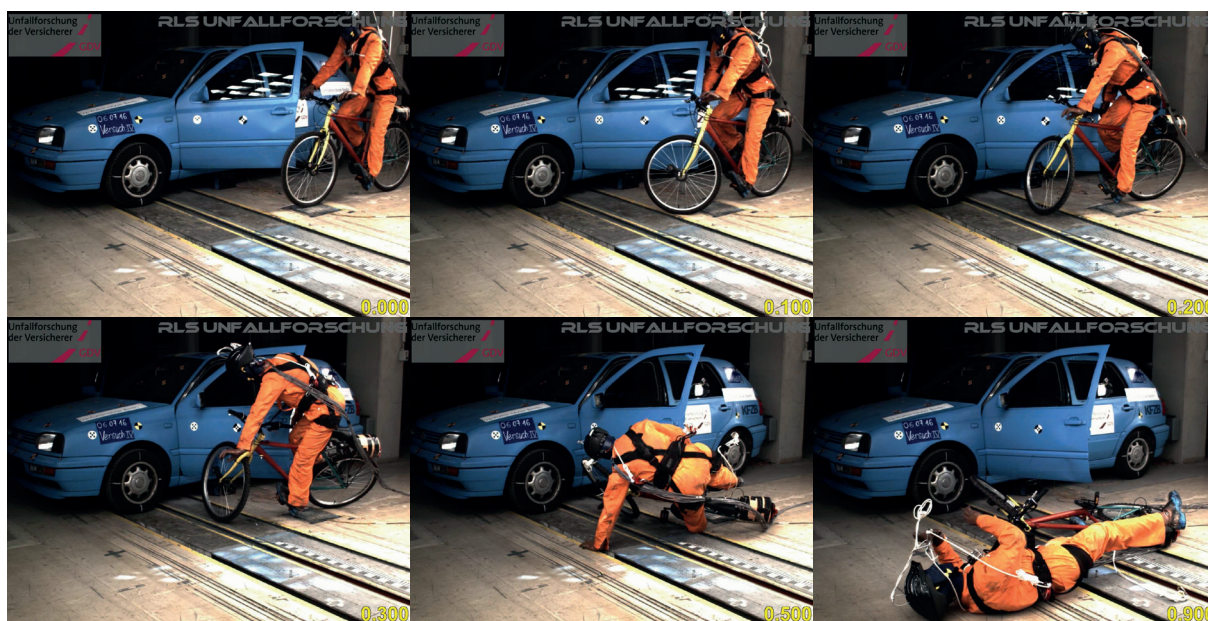
▲ Figure 15: Collision with a driver's door open at an angle of 45 degrees and with a small overlap in the handle area of the handlebar

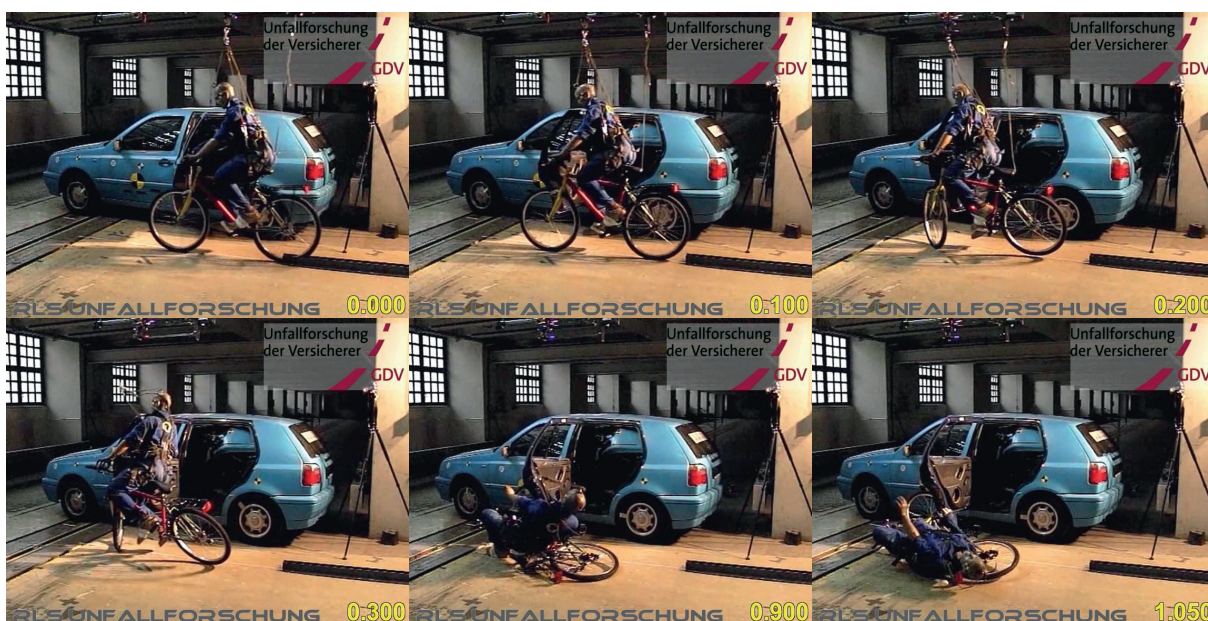
▼ Figure 16: Collision with a driver's door open at an angle of 90 degrees and with a small overlap in the handle area of the handlebar

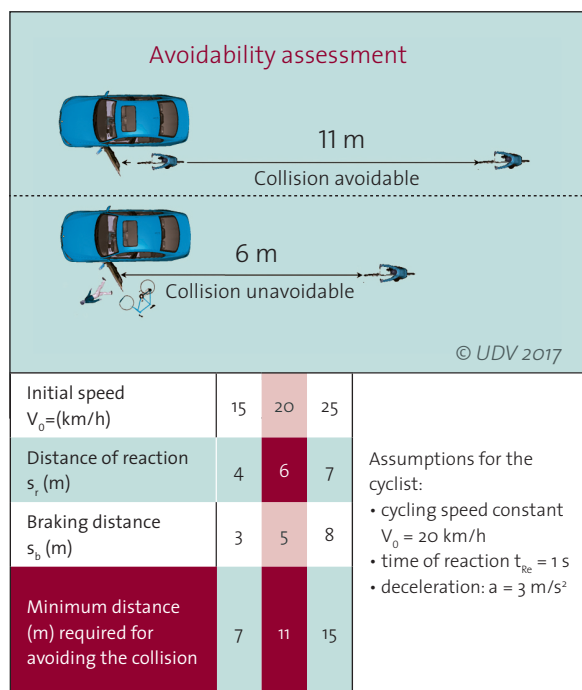
Figure 17 shows an example of the critical times and distances involved as a cyclist approaches a car. Assuming a reaction time of 1 second to recognize the danger (the driver's door opening in this case) and decelerating with 3 m/s^2 , a cyclist traveling at 20 km/h would have to be at least 11 meters from the door in order to avoid an accident. On the other hand, at a distance of 6 meters from the door (i.e. about 3 to 4 meters from the vehicle's rear end), the cyclist would have no chance of reducing speed and would therefore hit the door virtually without braking.

Figure 17: Simplified avoidability assessment for different distances between a cyclist and a car door, assuming the cyclist sees the open door, immediately initiates an emergency braking and comes to a halt (without crashing)

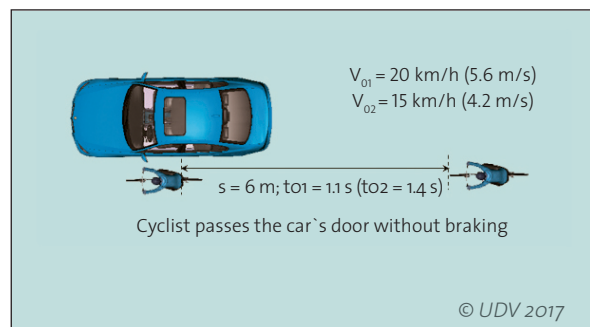
Figure 18: Theoretical assessment of the time required for a cyclist to pass at the point when the driver intends to open the door

There are already technical solutions available on the market for the door-opening scenario. These warn the driver when there are vehicles or cyclists approaching [6]. Much more promising, however, are systems that prevent the door from being opened in the event of danger. The time period required to allow a cyclist is relatively short, so there is no reason to expect it would be difficult for vehicle occupants to accept this (see figure 18). For example, a cyclist at a distance of 6 meters from the door

traveling at 20 km/h would have passed the car in about 1 second. Even for a slow cyclist (15 km/h), the door would only have to remain blocked for a maximum of 1.4 seconds. It can be assumed that drivers' acceptance of the system would increase once they had experienced its benefits directly.
