Compact accident research No. 89

Safety and usability of marked cycle lanes

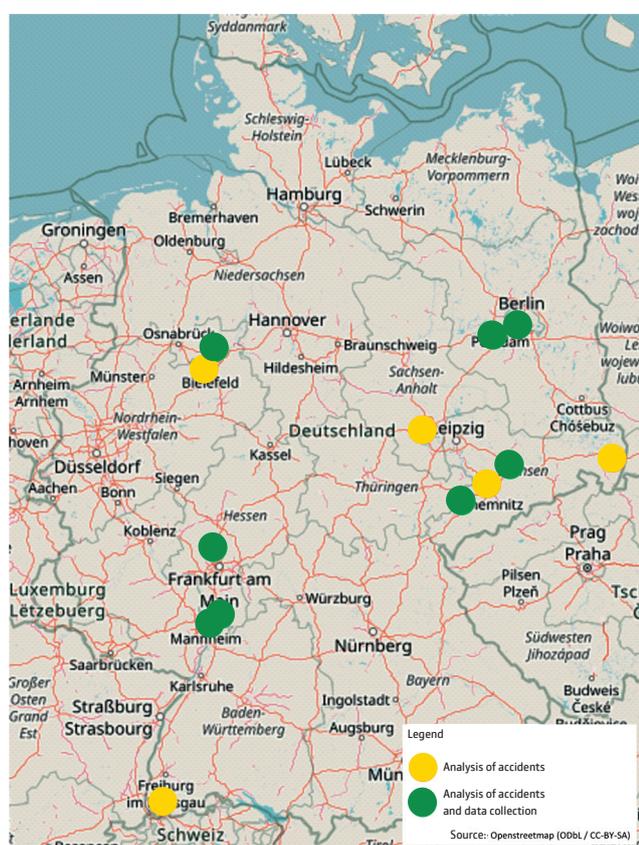
Figure 2: Locations of the stretches of road studied

A comprehensive analysis of the accidents that occurred was conducted for the selected stretches of road. A total of 644 cycling accidents involving injury occurred on these stretches of road. In 174 cases, it was possible to analyze descriptions of the accident circumstances. For 406 accidents in Berlin, it was possible to analyze the circumstances of the accidents more closely based on the collision symbols used in the Berlin accident statistics. A comparison group of cycling accidents on main
